Environmental Impact Assessment: Cotton Bay Resort Cotton Bay, Eleuthera, The Bahamas

MAY 2023

Waypoint Consulting Ltd
P.O. Box N4805
Nassau, The Bahamas
1-242-376-1448

Submitted to: Department of Environmental Planning & Protection
Submitted on behalf of: Cotton Bay Holdings Ltd.

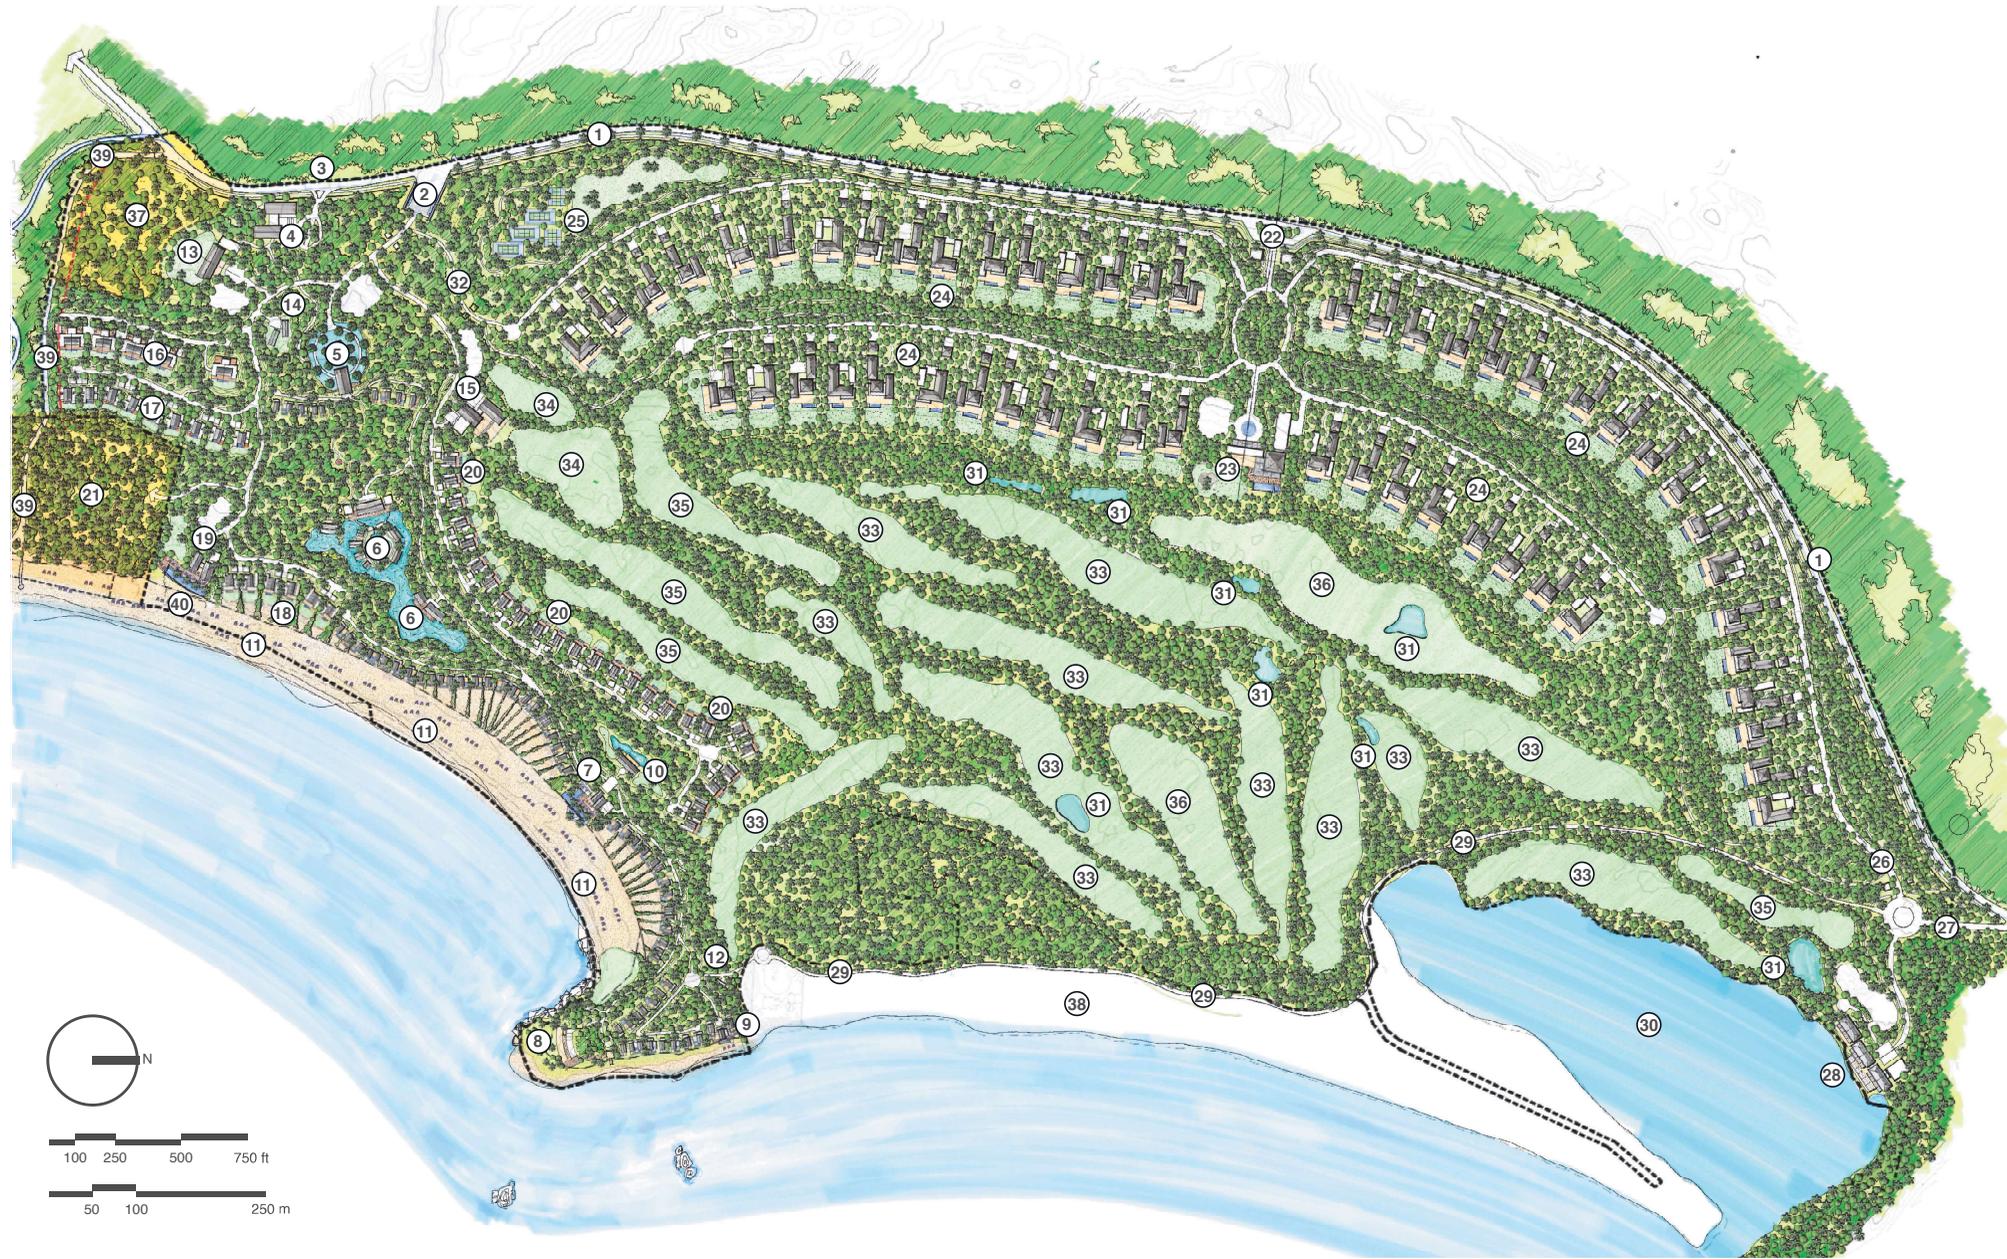
Overall Master Plan

OVERALL MASTER PLAN *MASTER PLAN GENERAL*

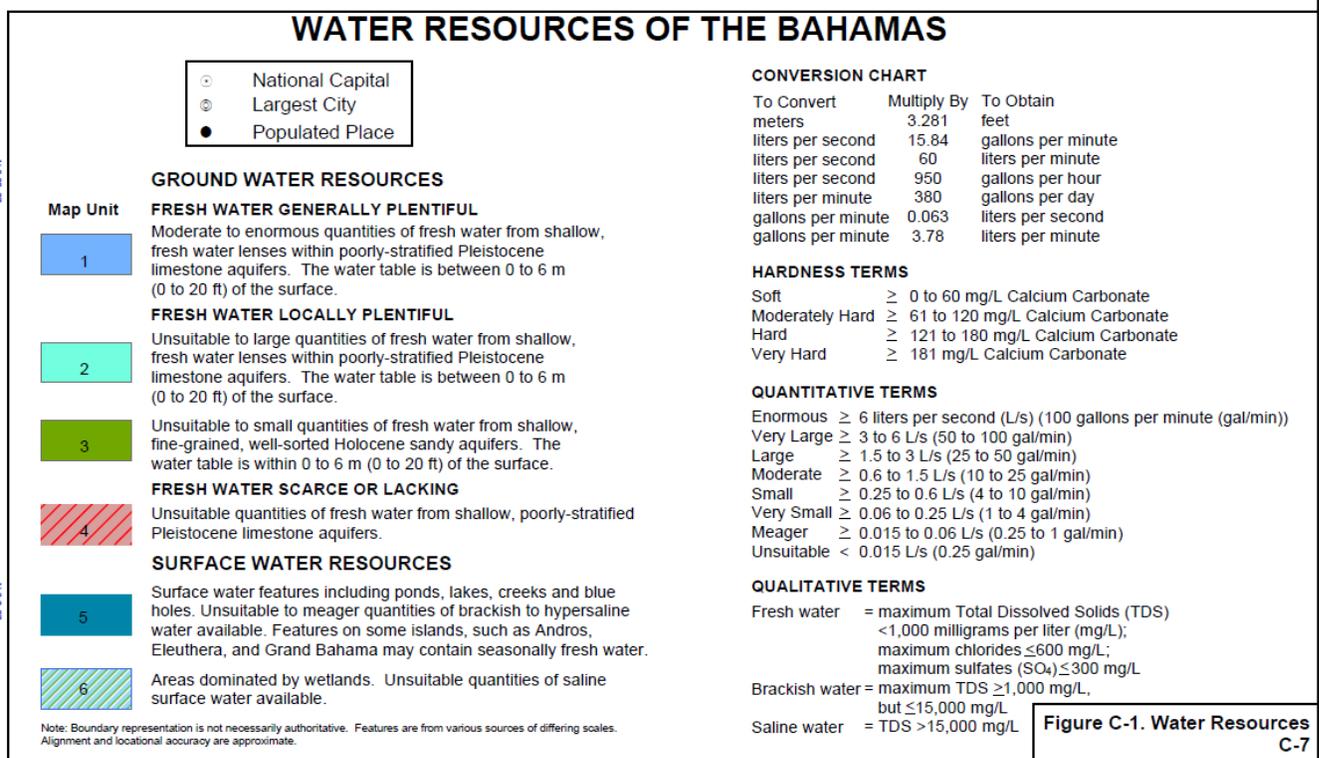
Figure 6-1 USACE Water Resources of The Bahamas

surface. ⁴ Annual rainfall averages approximately 110 centimetres (cm) (43 inches) per year per data retrieved on Eleuthera between 1961 and 1990. Freshwater resources may exist to the west of the Cotton Bay development where there were former cisterns. The golf course at Cotton Bay also has several cisterns for irrigation purposes. Large scale groundwater exploitation is not recommended for aquifers with lenses less than 30ft (9m).

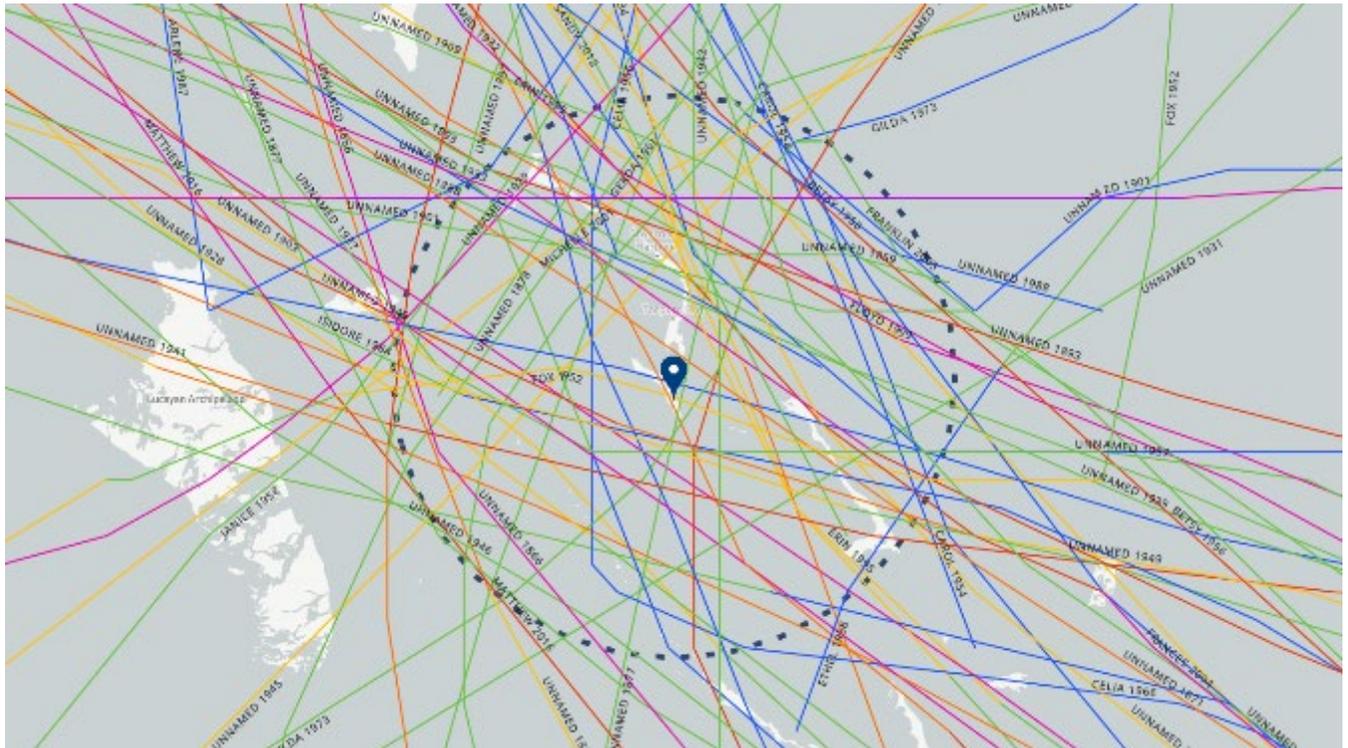
Figure 6-2 NOAA Historical Hurricanes within 60 Nautical Miles of Cotton Bay, Eleuthera, The Bahamas

Hurricane Dorian, one of the strongest hurricanes on record, made landfall at Elbow Cay, Abaco, in September 2019, with sustained winds of 160 knots. Although more than 90 nautical miles away, New Providence received high winds and rains over several days.

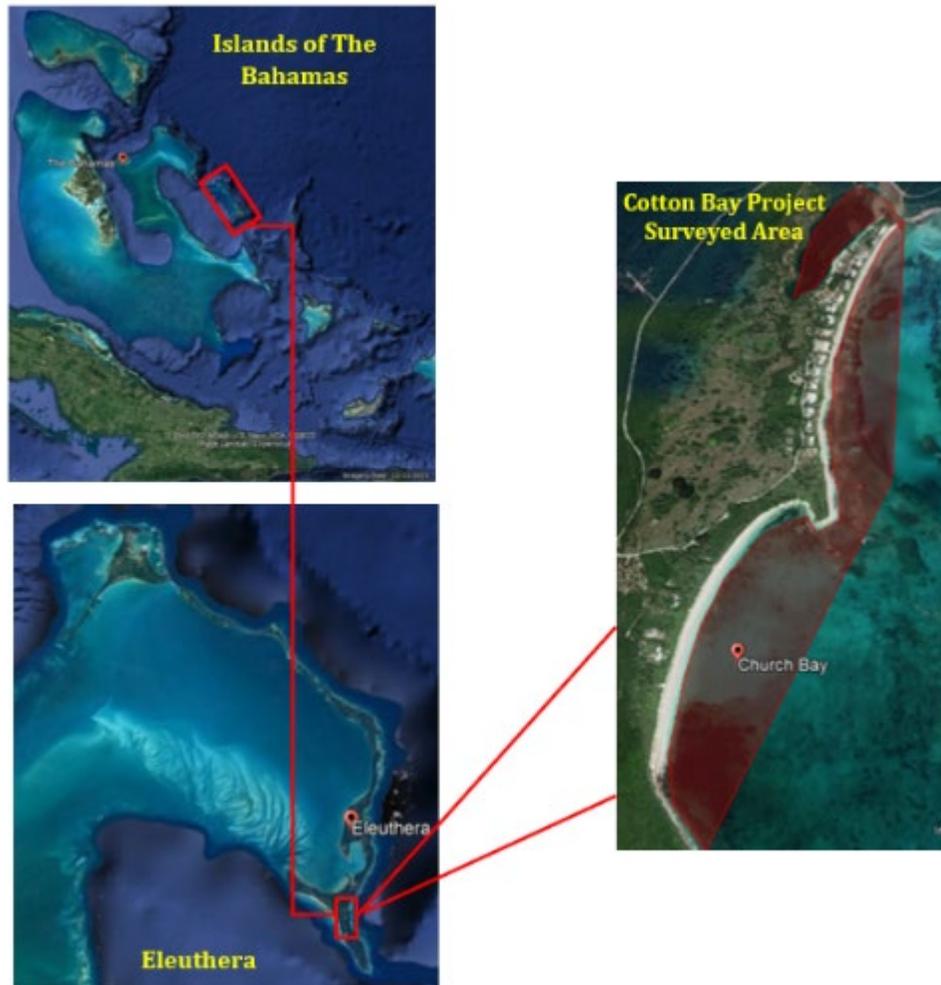
Figure 6-3 Marine Benthic Survey Area

The benthic ecosystem of the proposed area for the marine development was assessed using a roving transect method. Three divers swam along transects both parallel and perpendicular to the shoreline. Parallel transects ran the length of the survey area to record shoreline conditions. The perpendicular transects were taken from the shoreline to approximately 250 to 300 ft offshore, with divers swimming in an area approximately 50 ft wide. All flora and fauna species and substrate types were recorded. Species abundance was recorded as Single, Few (2 to 10) or Many (more than 10). The lead diver was responsible for recording fish species presence and abundance so that counts were not duplicated. The other divers would also record observations in the event the lead diver did not observe a certain species. Also, general observations were made for the surveyed areas. Data were collected underwater on slates and transcribed at the end of each day. Photographs and videos were taken. Species

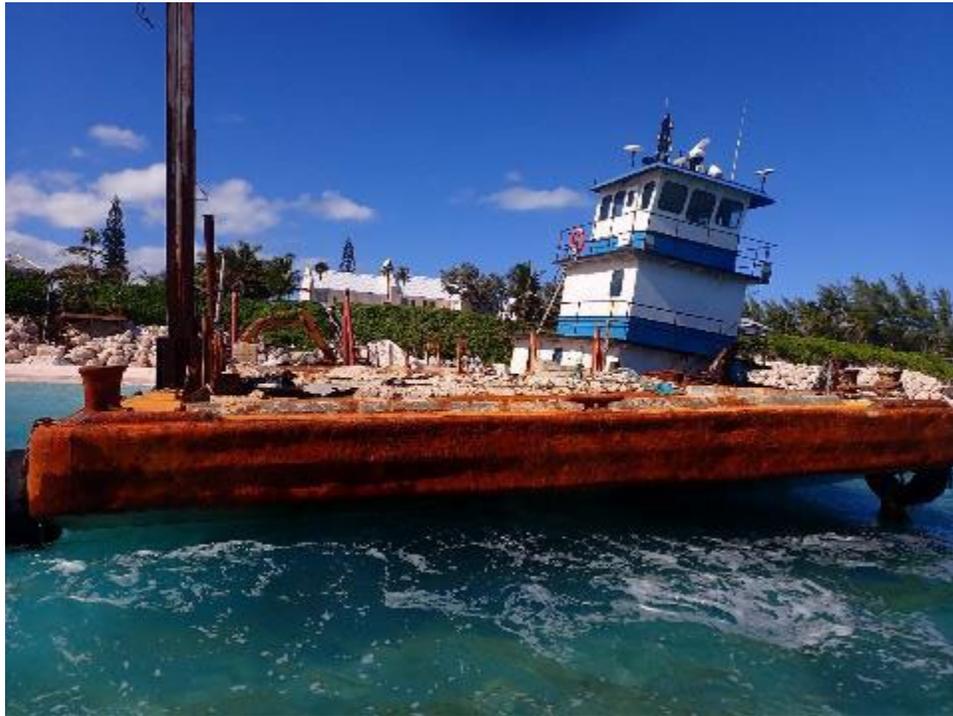
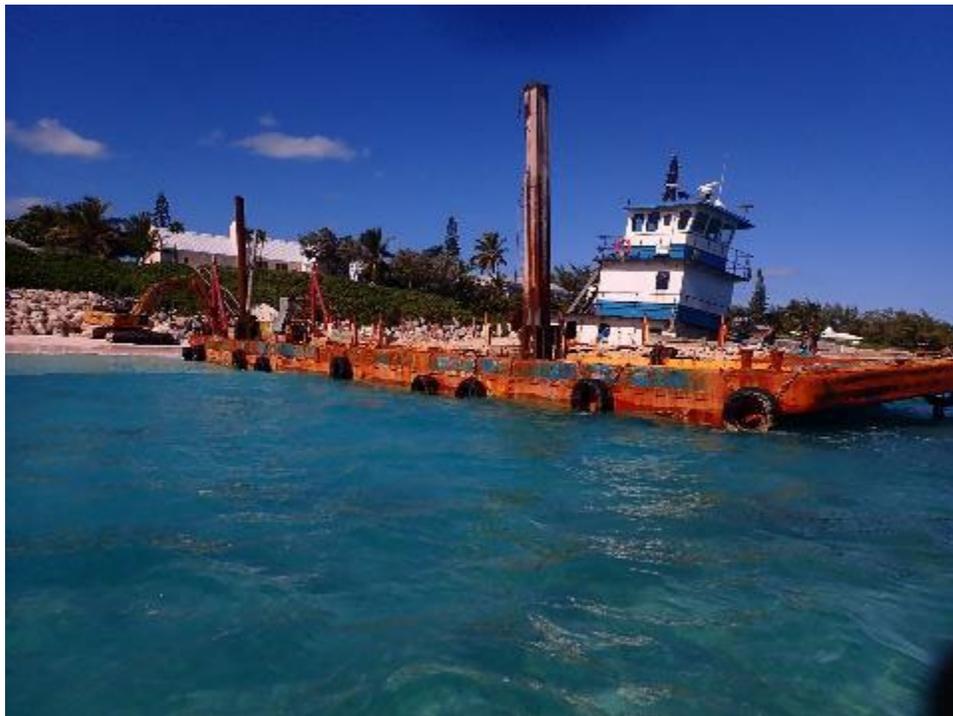
Figure 6-4 Immobilized Barge (Outside project area)

Figure 6-5 Immobilized Barge (Outside project area)

A barge and tugboat were observed to have run aground on the coast, south of the lagoon entrance. An excavator, likely to have been on the barge, was observed on the beach. Based on google imagery, it appears that the tugboat

went aground around end of October 2022. Of note, the stretch of homes along the ridge are outside the project area.

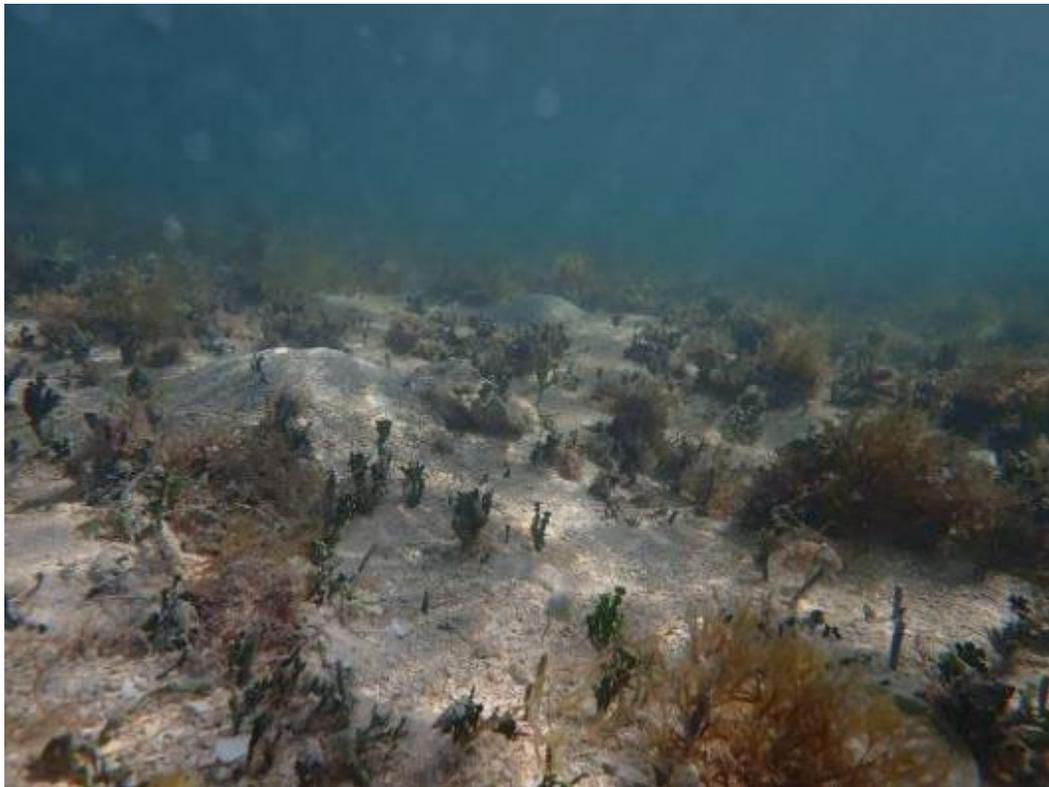
Figure 6-6 Sand with sparse Macroalgae

The benthic composition of the lagoon site had areas that transitioned from macroalgae beds to areas of sparse macroalgae. The main substrate was silt that transitioned to sand near the mouth of the lagoon. The predominant epifauna observed throughout this area was Upsidedown Jellyfish (*Cassiopea spp.*).

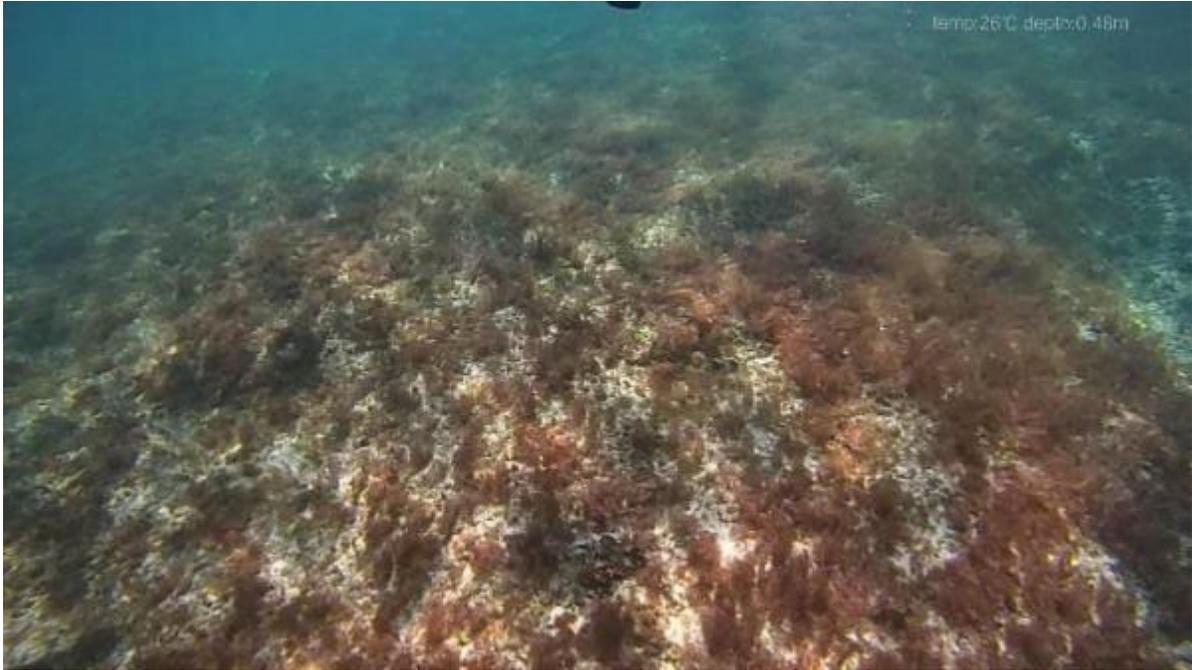
Figure 6-7 Hardbottom with macroalgae

Coastal areas were observed to transition from sandy-bottom to hardbottom and from hardbottom to reef. Various fleshy, film, and calcareous macroalgae was observed within the assessed areas. The various macroalgae observed in the area were determined to be the predominant flora species. Coral abundance was observed to be relatively low within the assessed areas.

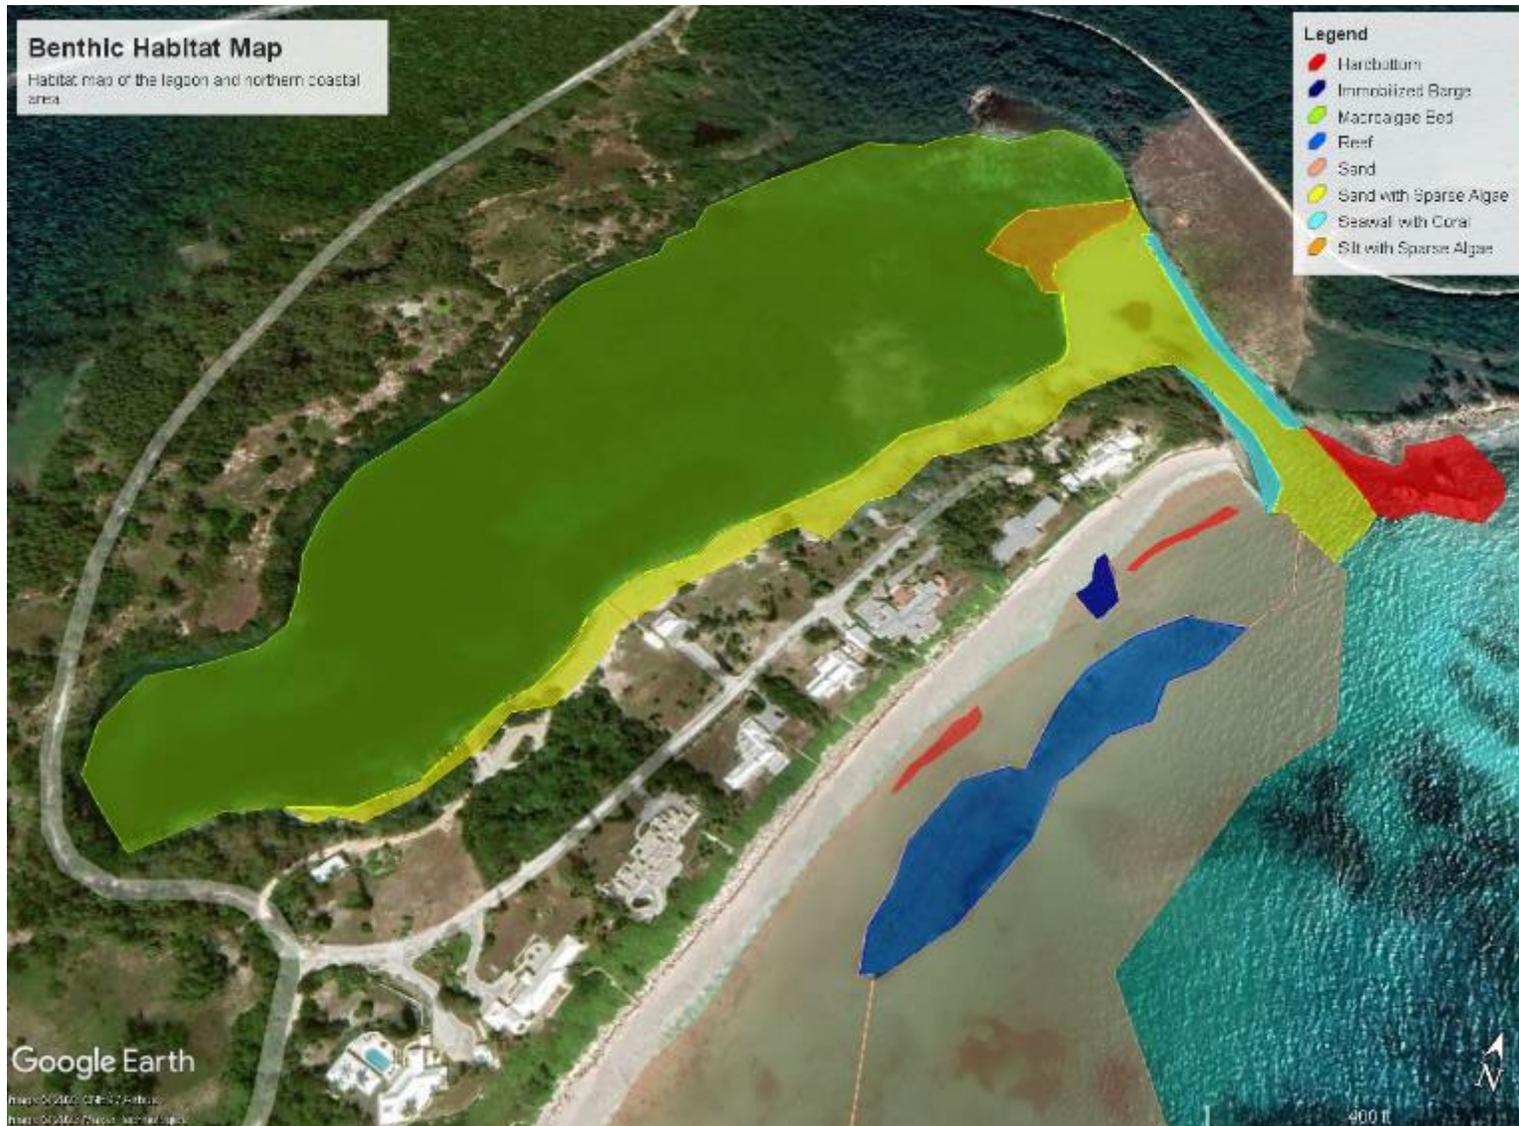
Figure 6-8 Cotton Bay Benthic Habitat Map (Lagoon and Coastal Habitat)

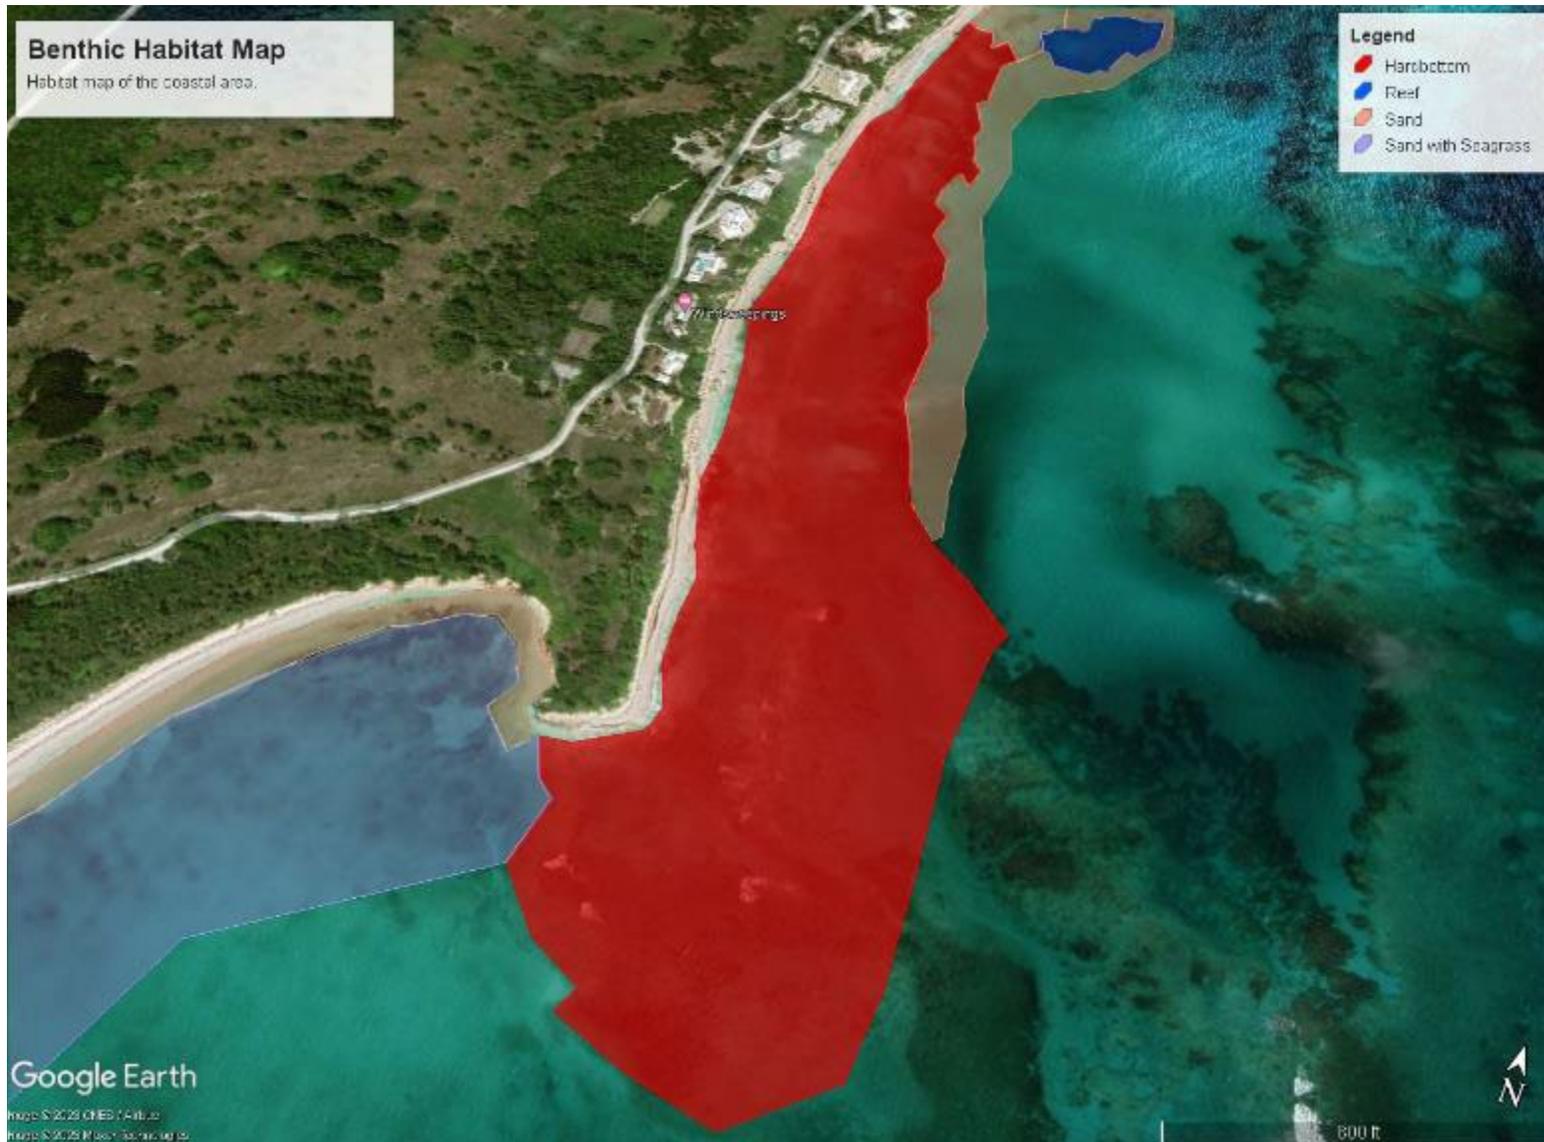
Figure 6-9 Cotton Bay Benthic Habitat Map (Coastal Habitat)

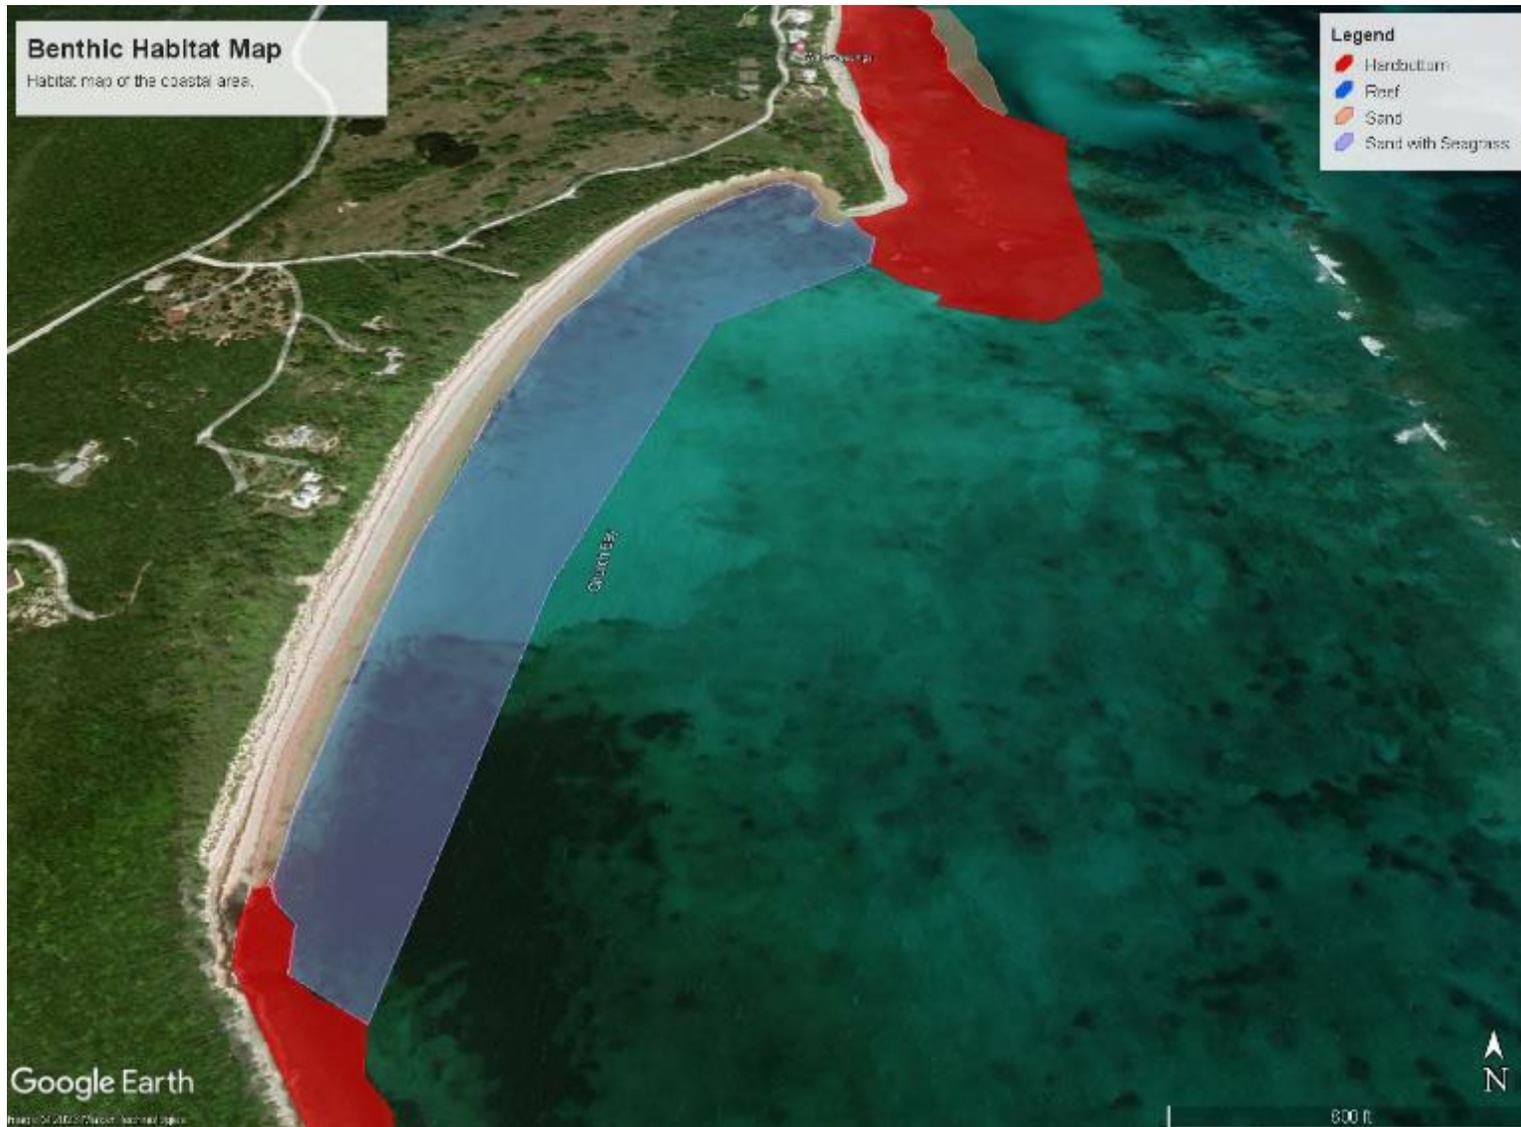
Figure 6-10 Cotton Bay Benthic Habitat Map (Coastal Habitat)

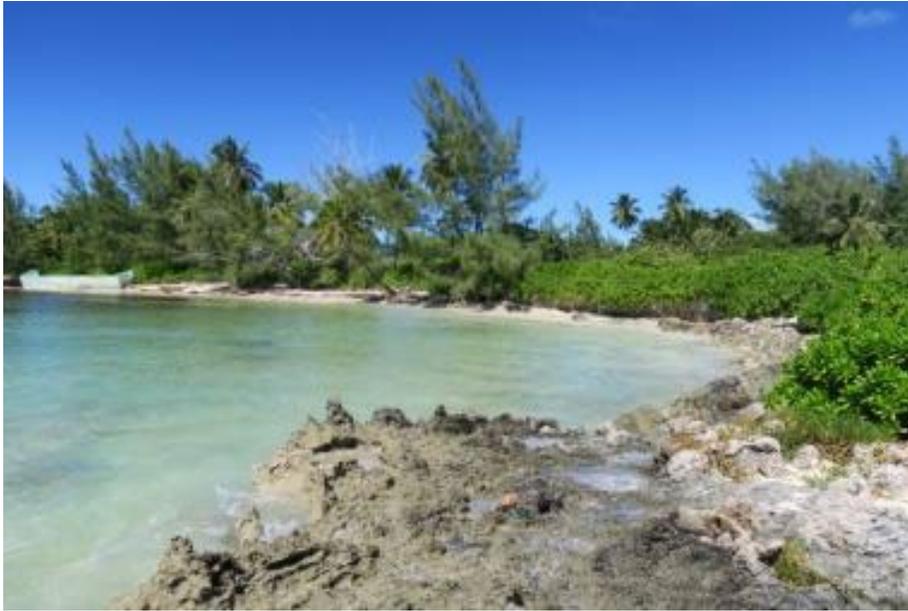
Figure 6-23 Ironshore along coastline (view facing west)

Rocky shoreline formation along the coast includes accumulated gravel with no vegetation present along the coast and within the lagoon perimeter as well as ironshore with the invasive *Casuarina equisetifolia* (Australian Pine) and *Scaevola taccada* (Hawaiian Sea grape). Native species included *Sesuvium portulacastrum* (Sea purslane) and *Sporobolus virginicus* (Seashore rush grass) sparsely distributed in rock crevice in front of invasive species. *Rhachicallis americana* (Sandfly Bush) that typically dominates rocky shorelines was noticeable absent.

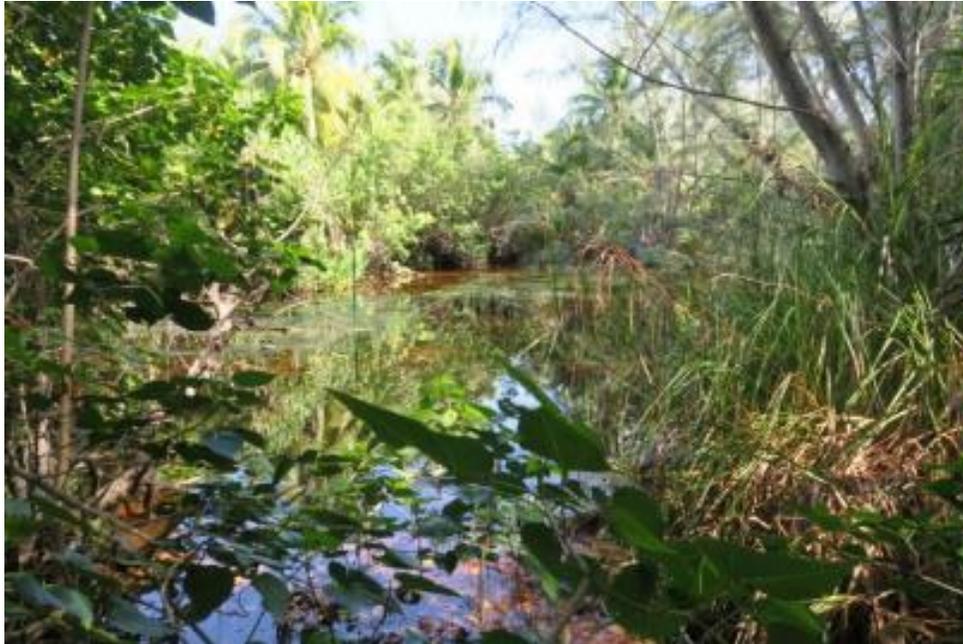
Figure 6-27 Golf Course Pond with Saw grass and Australian Pine

There are fifteen (15) small man-made ponds within the golf course area of the site. These features range in size from 0.11 to 1.2 acres. Substrate conditions within the ponds ranged from saturated to standing water 1-2 feet in depth. Vegetation surrounding the ponds was typically *Cladium jamaicense* (Sawgrass). Associated species included wetland species such as *Thespesia populnea* (Cork Tree), *Sabal palmetto* (Sabal Palm), *Sesuvium portulacastrum* (Sea purslane) and *Typha domingensis* (Cattail). The invasive *Casuarina equisetifolia* (Australian Pine) is present on the outer periphery of many of the formations. There is a large *Ficus benghalensis* (Banyan Tree) on periphery of one of the Golf Course Ponds.

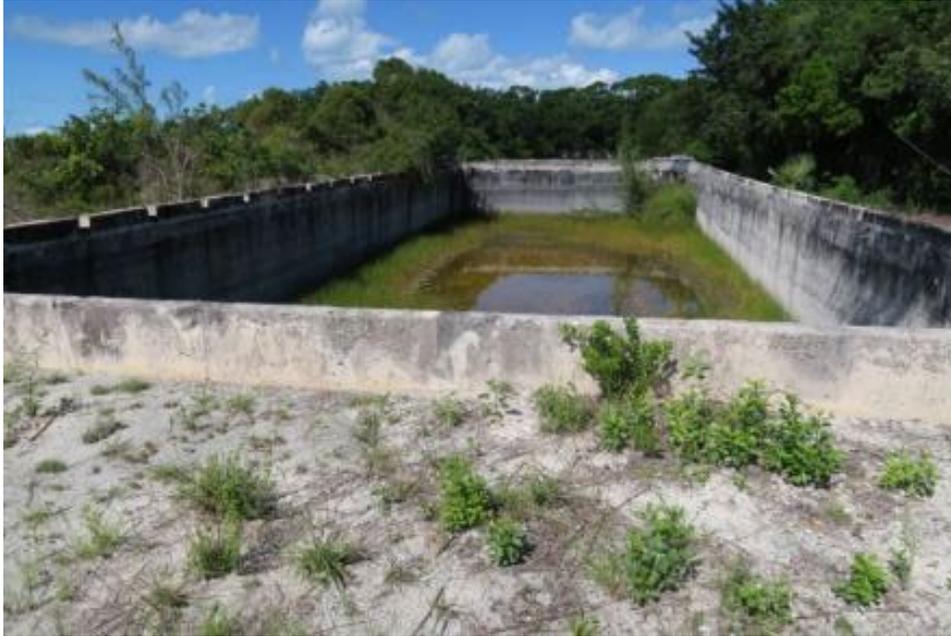
Figure 6-29 Cisterns in the interior upland vegetation

There are three (3) concrete cisterns in the interior upland vegetation that has rainwater accumulation. *Eleocharis cellulosa* (Spike rush grass) is the predominant vascular plant species within these structures. Other species present include *Cladium jamaicense* (Sawgrass) and *Casuarina equisetifolia* (Australian Pine).

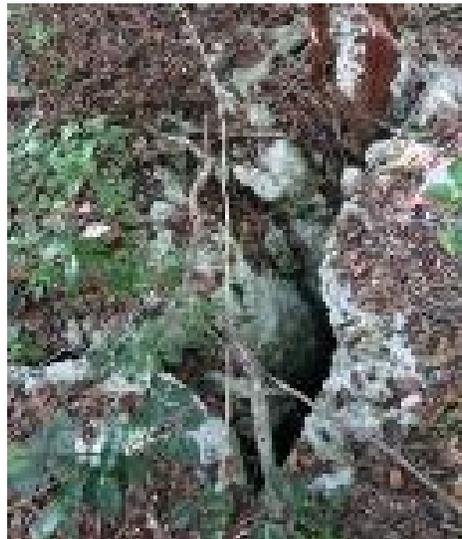
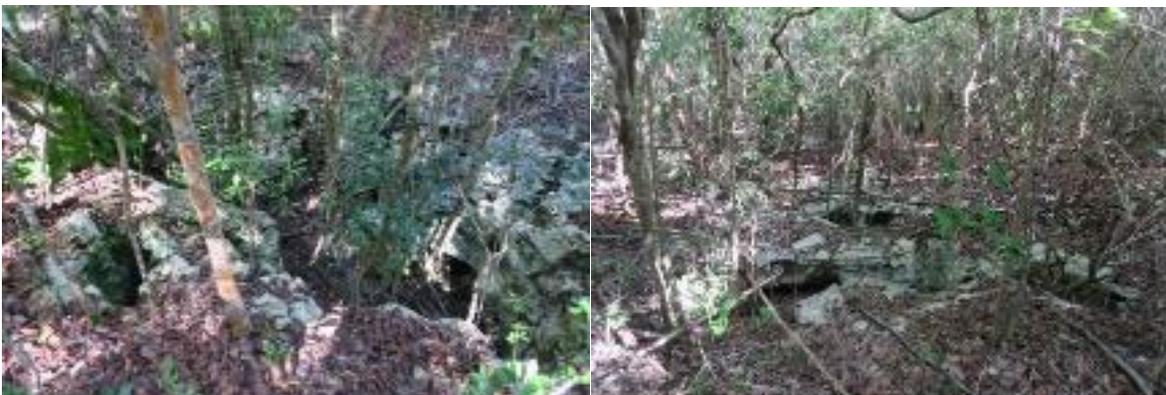
Figure 6-31 Abundance of karst features (dissolution holes) in DBEF

Karst features (dissolution holes) are common in the DBEF.

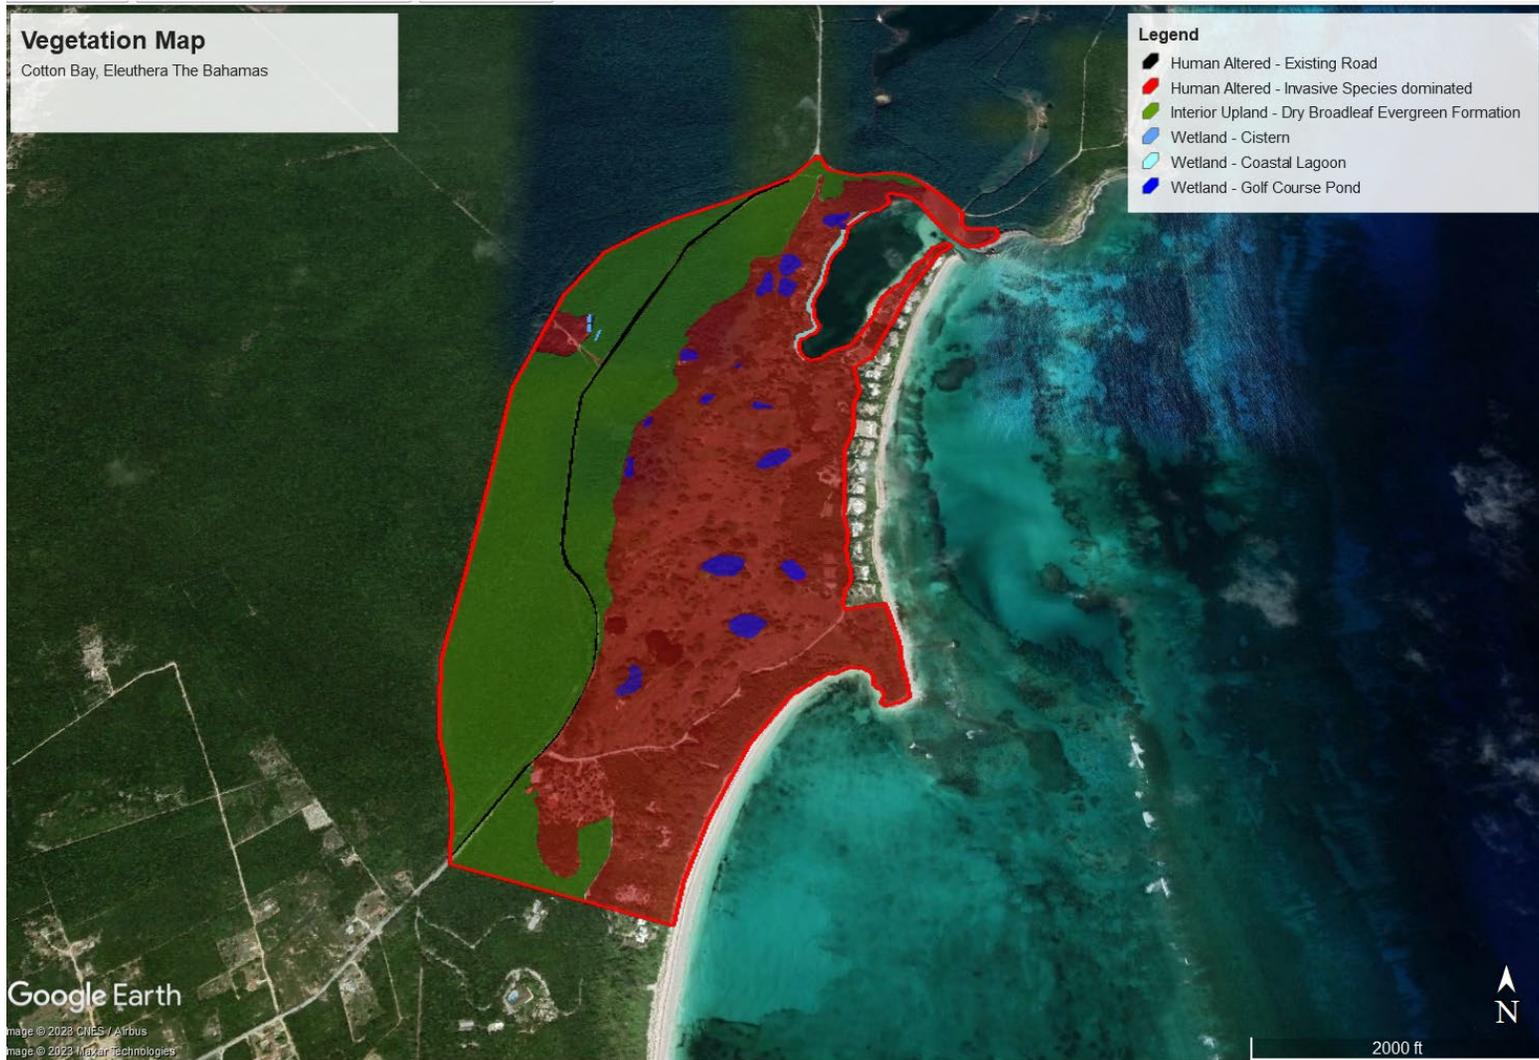
Figure 6-35 *Vegetation Map, Cotton Bay, Eleuthera*

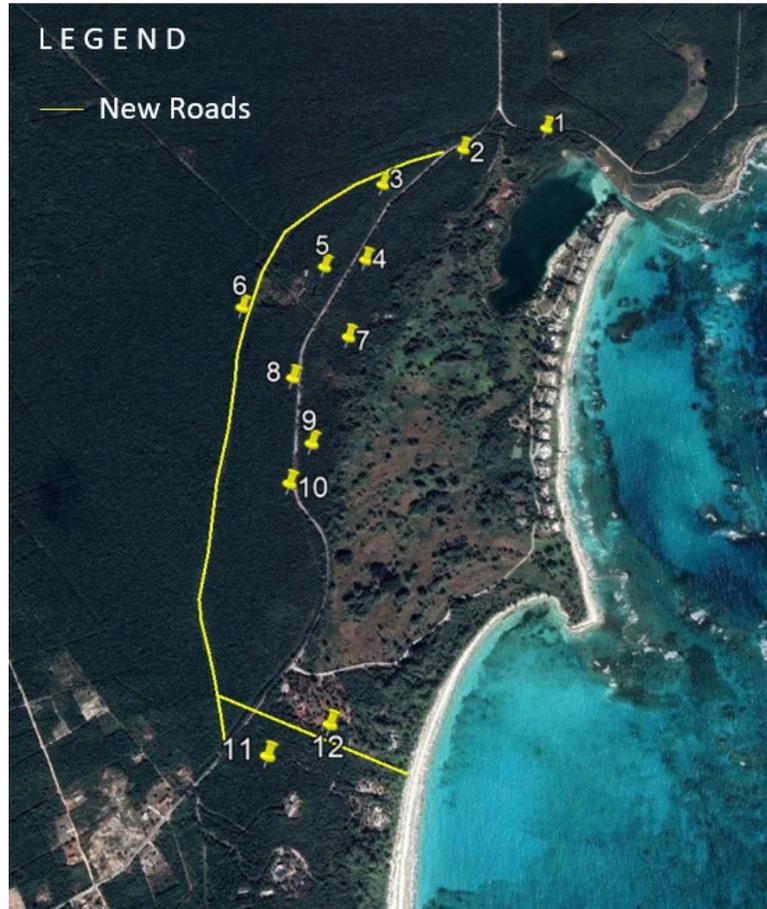
Figure 6-36 Protected Tree Species Survey Locations

To estimate the number of protected species that may be impacted in the approximately 170 acres of native DBEF vegetation, the average number of each species recorded in the 0.1-acre plots was multiplied to by 10 to calculate the number for each species that are likely to be in 1-acre. The calculations for 1-acre was multiplied by the total number of acres to be impacted for the overall number of species within the vegetation type.

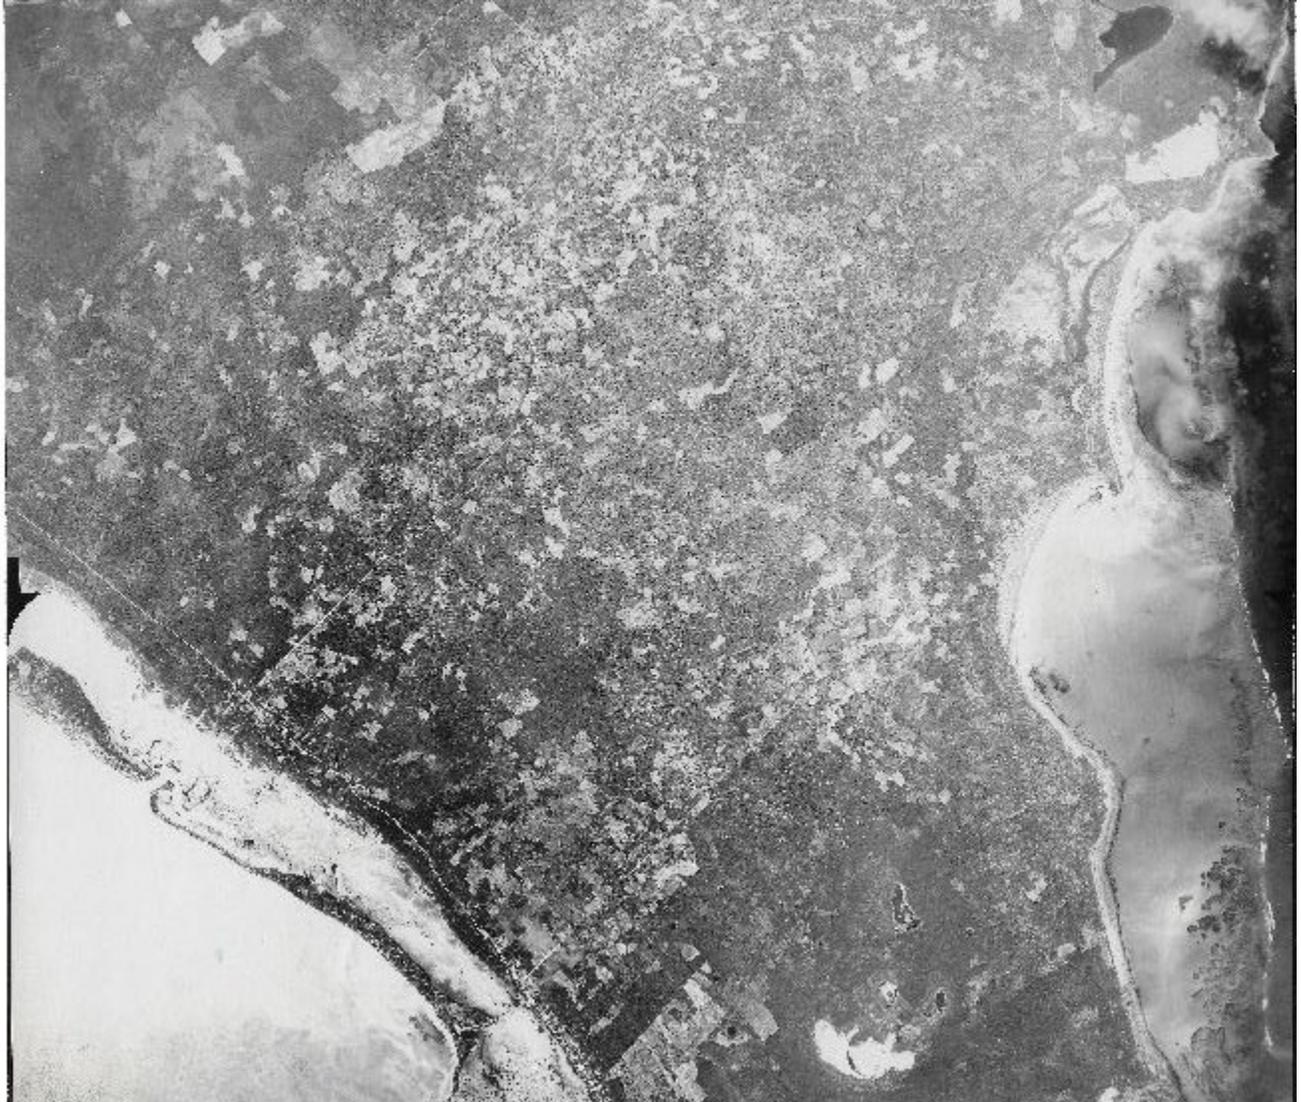
Figure 7-1 Historic Aerial ~1942

Historic aerials offer a visual glimpse of historic land use before the availability of satellite imagery. Land use in South Eleuthera during this period is marked by small plots of cleared land for agricultural use and settlements. Even prior to the Cotton Bay Club, this area was influenced by human activities. Notably, the lagoon area referred to as the “yacht harbour” on later land resource maps is an isolated pond with no connection to sea seen below. There are no indications that historic resources exist on the site; should construction activities make a discovery of antiquity, protocols outlined in the Environmental Management Plan will guide the workforce.

By 1958, construction of the Cotton Bay Club was well underway with the Cotton Bay Club opening for business in 1959. The pond was excavated and connected to the sea for the future but never fully completed ‘yacht harbour’. The golf course is under construction with irrigation ponds interspersed throughout the course.

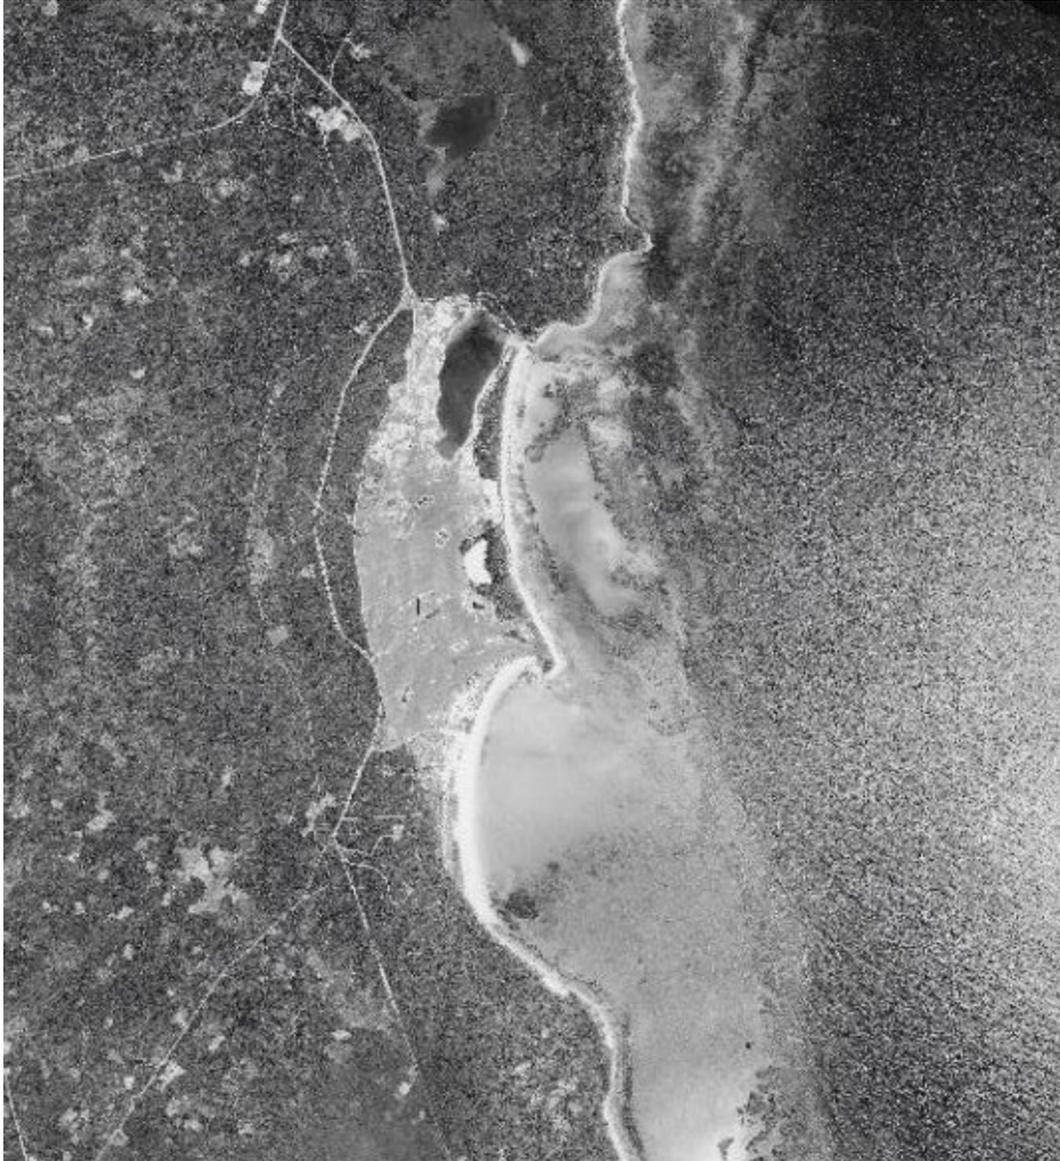
Figure 7-2 Historic Aerial 1958, Cotton Bay Club, South Eleuthera
