Environmental Impact Assessment: Cotton Bay Resort Cotton Bay, Eleuthera, The Bahamas

MAY 2023

Waypoint Consulting Ltd
P.O. Box N4805
Nassau, The Bahamas
1-242-376-1448

Submitted to: Department of Environmental Planning & Protection
Submitted on behalf of: Cotton Bay Holdings Ltd.

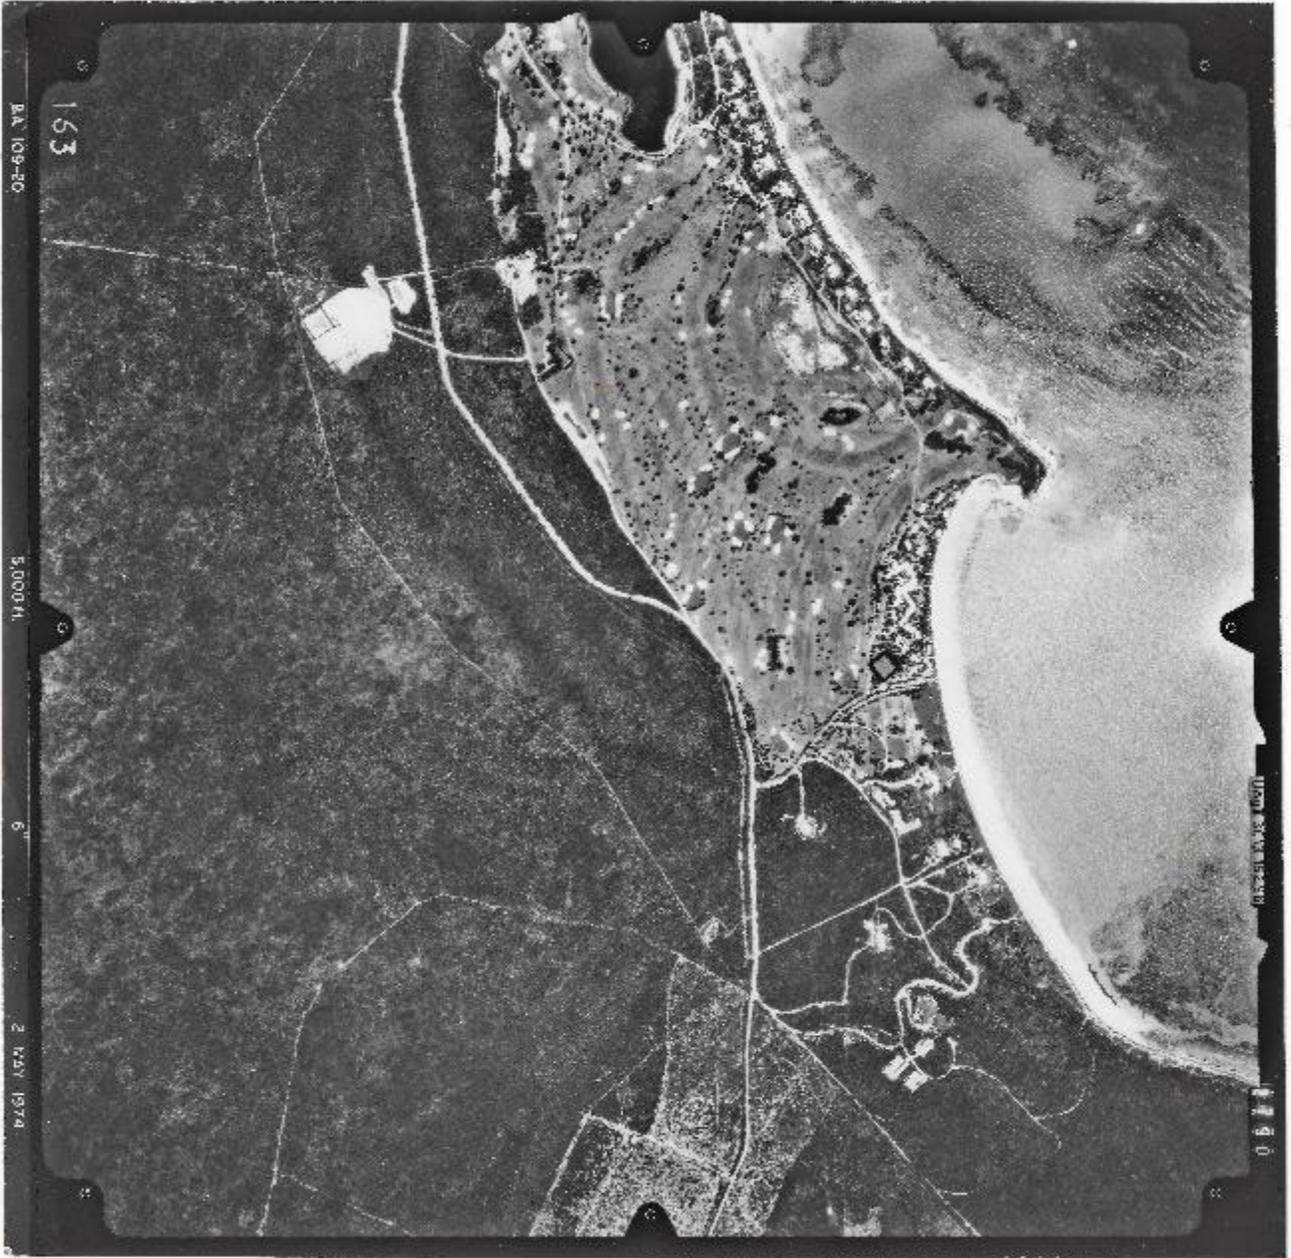
Figure 7-3 Historic Aerial 1974, Cotton Bay Club, South Eleuthera

By 1974, homes had been constructed along the narrow ridge between the golf course and the Atlantic Ocean. The water catchment basin for west of Cotton Bay Drive is clearly visible.
